Project: **TEMPORARY DEFENCES DEPLOYMENT PLAN**

Title: **SAINT MARY BOURNE DEPLOYMENT PLAN**

Client: **Environment Agency**

Drawn: B.MOHAMMED	01/07/22	Designed: M.RAI	01/07/22
Checked: Y. AL-JEIROUDI	21/07/22	Approved: C.FOSBEARY	07/12/22
Project Reference: 2021s1519	Scale: AS SHOWN		
Drawing Number: ENV0004514C-JBA-XX-0136-DR-Z-1101	Status: A5	Revision: C01	Sheet Size: A1

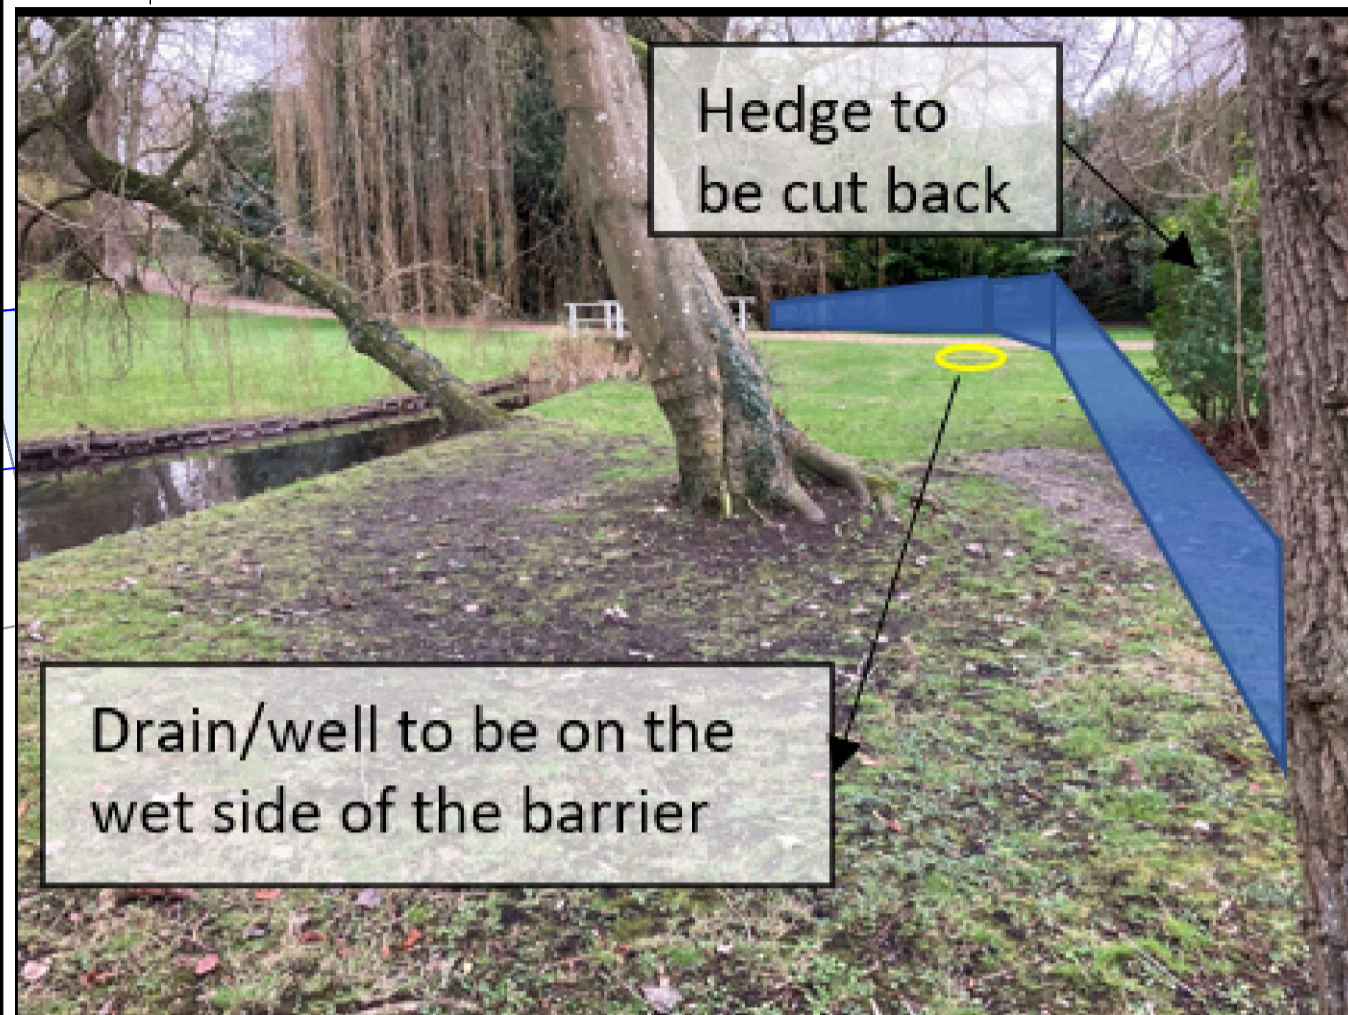
Hedge to be cut back

Drain/well to be on the wet side of the barrier

PHOTO C: BARRIER DEPLOYMENT LINE TO THE BRIDGE AT MUNDAYS

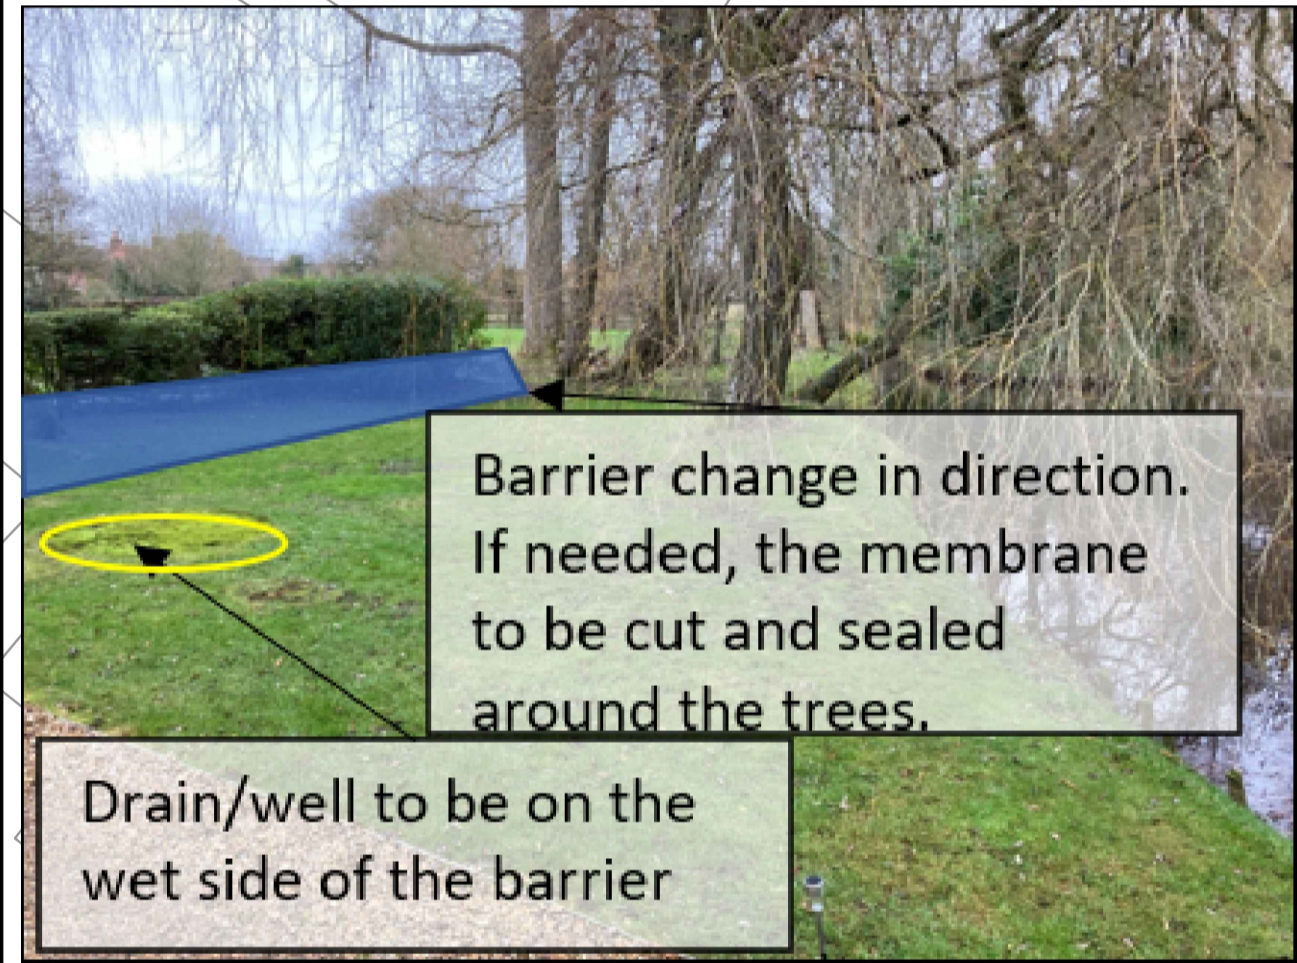
Barrier change in direction. If needed, the membrane to be cut and sealed around the trees.

Drain/well to be on the wet side of the barrier

PHOTO B: BARRIER CHANGE IN DIRECTION AT NORTH CORNER OF THE LODGE. THE PHOTO SHOWS THE DRAIN / WELL LOCATION

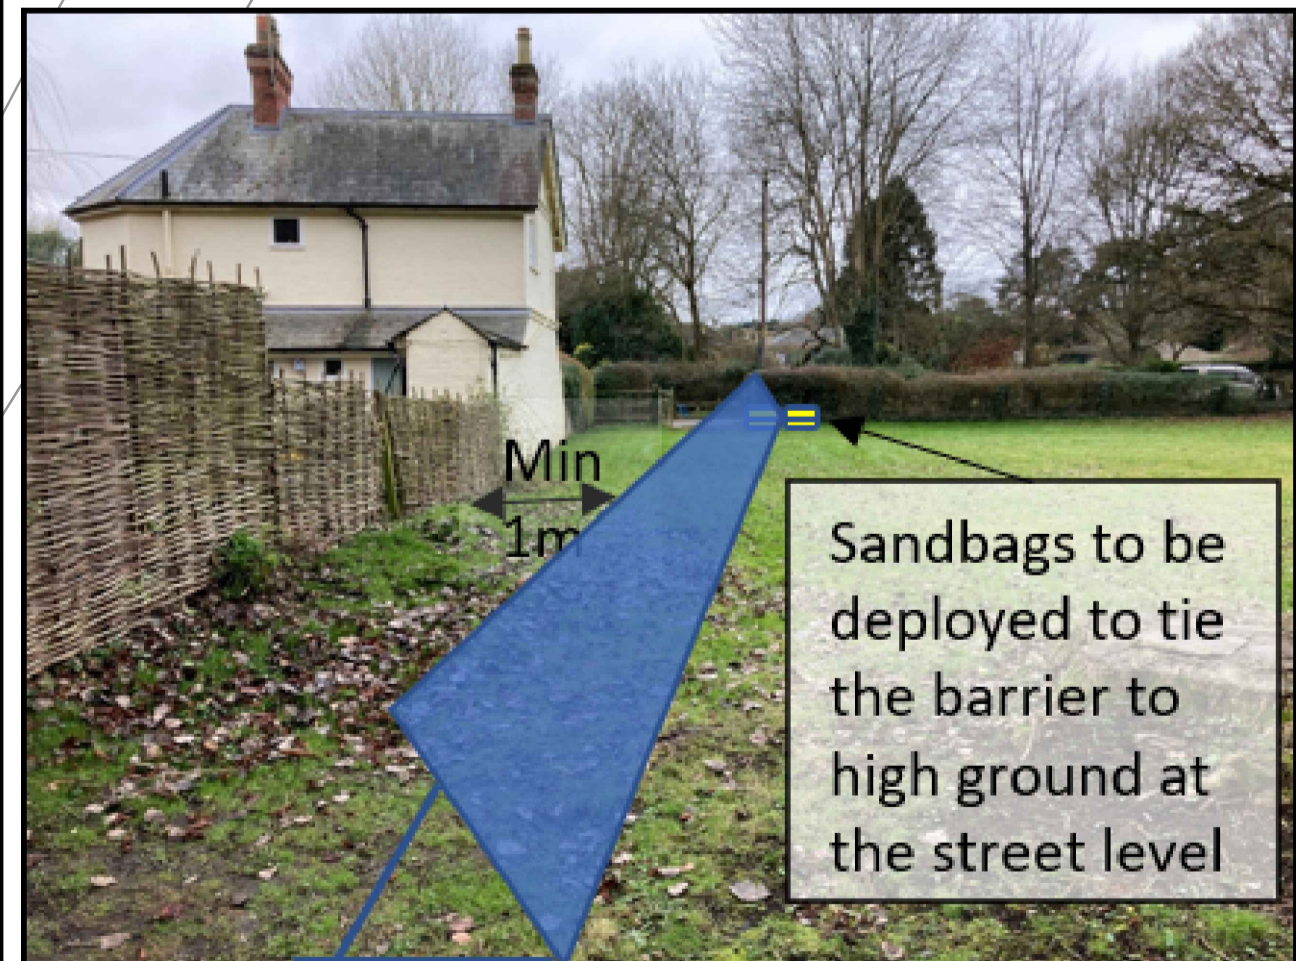
Sandbags to be deployed to tie the barrier to high ground at the street level

PHOTO A: BARRIER PARALLEL TO SPRINGHILL LODGE WITH 1m MAINTENANCE CORRIDOR ON THE DRY SIDE OF THE BARRIER
